FIBREGLASS PUMP STATIONS: 10 YEARS EXPERIENCE IN NEW ZEALAND

Presented at the Water New Zealand Conference, Rotorua, November 2011

Holyoake, K.M.; ARMATEC Environmental Ltd, and Guthrie, B.C; ITT Water & Wastewater NZ Ltd

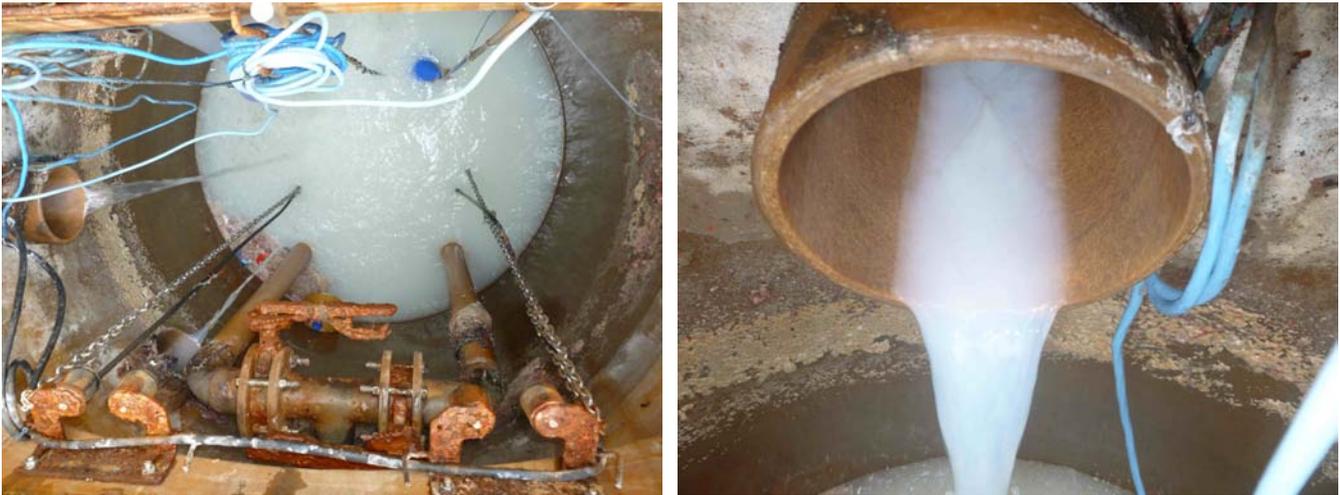
A fibreglass pump station was installed in a Dairy Factory in 2000. It was manufactured in vinyl ester resin, and handles CIP effluent including up to 5% nitric acid, up to 5% caustic, hot water, and milk wastes. Evaporator water has at times exceeded 95°C. The thermal shock from sudden changes in temperature has caused surface crazing on the internal surface of the fibreglass pipe (Photograph 10) that drains the evaporator to the pump station. This is superficial only, and has not led to failure. The resin rich interior surface of all fibreglass parts is reinforced and strengthened with a fine glass tissue, giving it improved physical characteristics to handle these thermal stresses. All parts of the pump station are contact moulded for the highest degree of chemical resistance, and this is especially needed in this application. The main laminate is reinforced with non-continuous glass fibre, and this limits the spread of any chemicals within the laminate should significant cracks develop.

Valve handles and other non-stainless steel metal parts within the pump station are being corroded (Photograph 9).

Photographs 9 & 10. Fibreglass pump station at Dairy factory after 11 years service handling milk products and CIP chemicals at temperatures to 95°C. Internal surface of inlet pipe has crazed, but is still structurally sound.

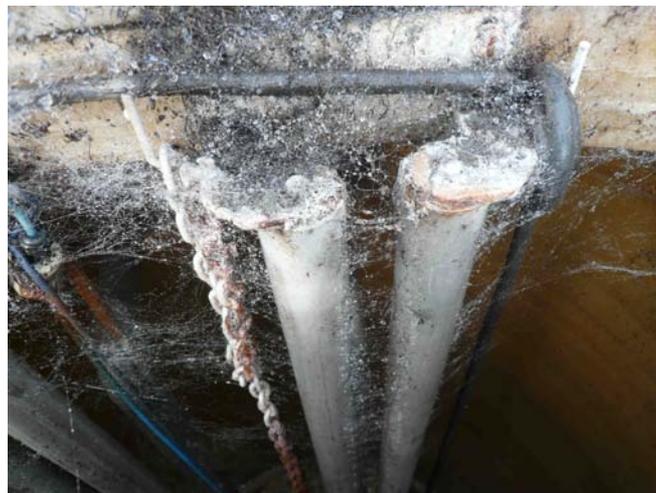
A fibreglass pump station was installed in the Mangaroa Prison in Hawkes Bay in 2005. After 6 years operation, it is in excellent condition. The load is intermittent, with low-level buildup of hydrogen sulphide gas. Non-stainless steel parts within the pump station have corroded, and will need maintenance in the future.

Site personnel advised that the pump station is hardly ever touched, other than being cleaned out every 3 to 4 months. Management of the prison changed in 2010, and servicing had possibly been neglected in the past. The spider webs present (Photograph 11) confirm there has been minimal servicing. The fibreglass pump station itself has not suffered as a result of infrequent service.

Photographs 11. Fibreglass pump station at Hawkes Bay prison handling wastewater is in excellent condition, despite minimal servicing. Non-stainless steel metal parts are being corroded by hydrogen sulphide gas.

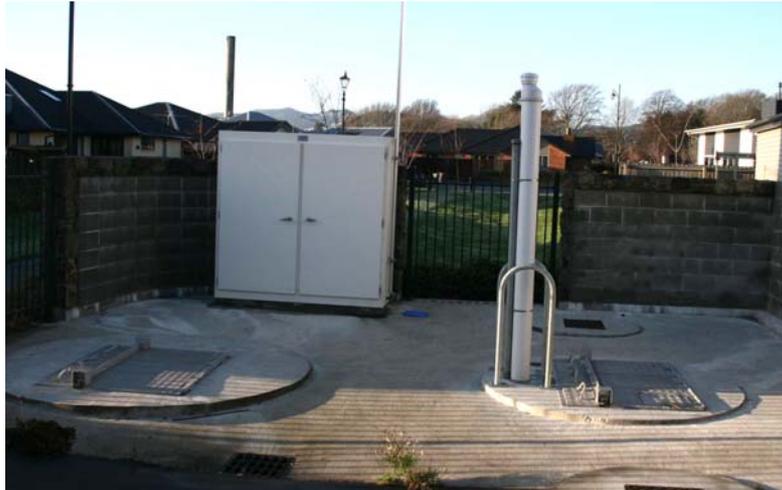
The Linden Grove Ave pump station (PS96) was installed in 2008. It is located about 4km southwest of the city centre, and has endured more than 6,000 earthquakes during 2010 and 2011, without damage. The pump station and valve chamber are located close together. They are connected by rigid ductile iron piping, and a reinforced concrete slab ties the two together. The lack of damage is likely due to the two being tied together, so that there is minimal differential movement during an earthquake.

Photograph 12: Linden Grove Pump Station, Christchurch (PS96). No damage during earthquakes of 2010 and 2011. Pump station and valve chamber are close, and tied together with concrete slab.

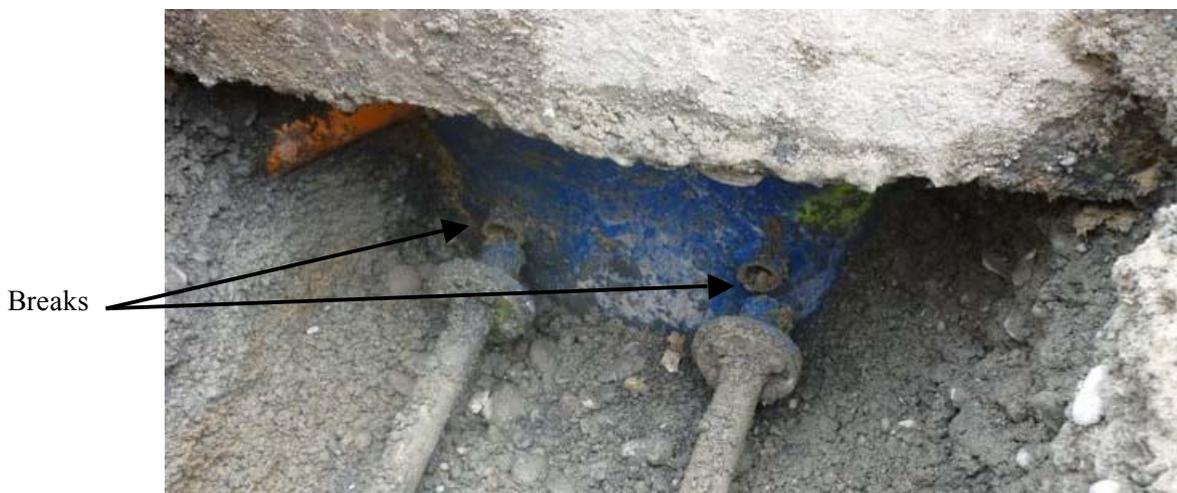
The Birchgrove pump station (PS97) was installed in 2009. It is located to the east of the city centre, closer to the area worst affected by the 2010 and 2011 earthquakes. The two 50mm diameter pump station discharge pipes include flanged fibreglass spools at the pump station wall, followed by a ductile iron pipe to the valve chamber. During the 22 February 2011 earthquake, both discharge pipes sheared immediately outside the pump station in the fibreglass spool section (Photograph 13). The liquid tight envelope of the fibreglass vessel itself was not broken.

An unusual aspect of the Christchurch earthquakes was the significant vertical acceleration that occurred, in addition to the normal horizontal acceleration. A significant amount of the damage to Christchurch City buildings, and pump stations, was a result of this vertical acceleration component.

When excavated, the pipes were found to be displaced both horizontally and vertically by 20mm to 50mm. It is likely the pump station and valve chamber moved during the earthquake, and that the backfill around the discharge pipes compacted downwards. As the discharge pipes were rigid ductile iron, there was no flexibility to take up any movement, and the breakage resulted.

Photograph 13: Birchgrove Pump Station, Christchurch (PS97): Discharge pipes broke during 22 February 2011 earthquake at fibreglass spool just outside pump station wall.

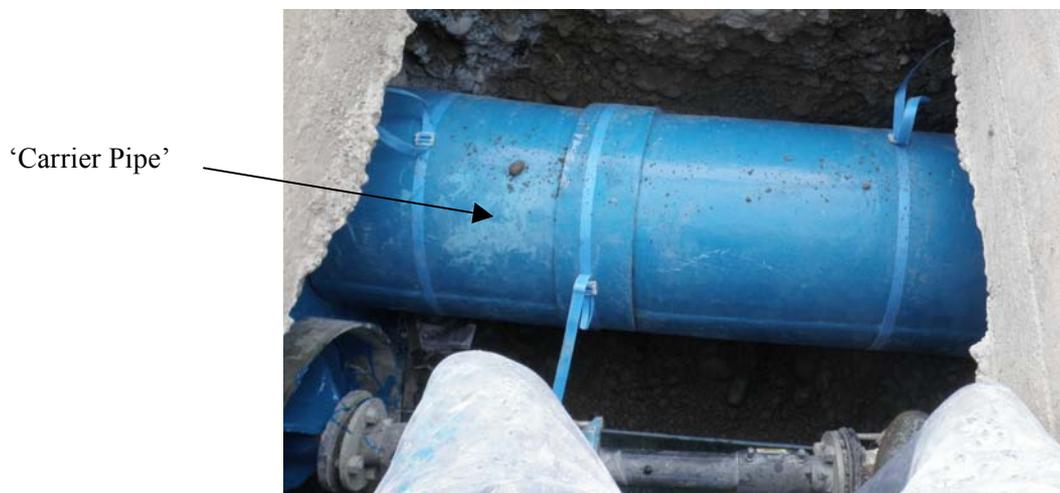
Photograph 14: Birchgrove Pump Station, Christchurch (PS97) Earthquake Damage Repairs: (1) Fibreglass nozzles strengthened, HDPE pipe used, and 'Carrier Pipes' being installed to provide room for movement.

Repairing the breaks in these fibreglass pipe spools was relatively straight forward, as the break was outside the pump station. The rigid ductile iron pipes have been replaced with HDPE piping, and trial 'Carrier Pipes' were

installed. This provides more flexibility and room for movement of the pipe connecting the pump station and valve chamber. The 'Carrier Pipes' are fibreglass, with a diameter between 4 and 6 times the discharge pipe diameter. They also provide protection to the HDPE piping during any future excavation.

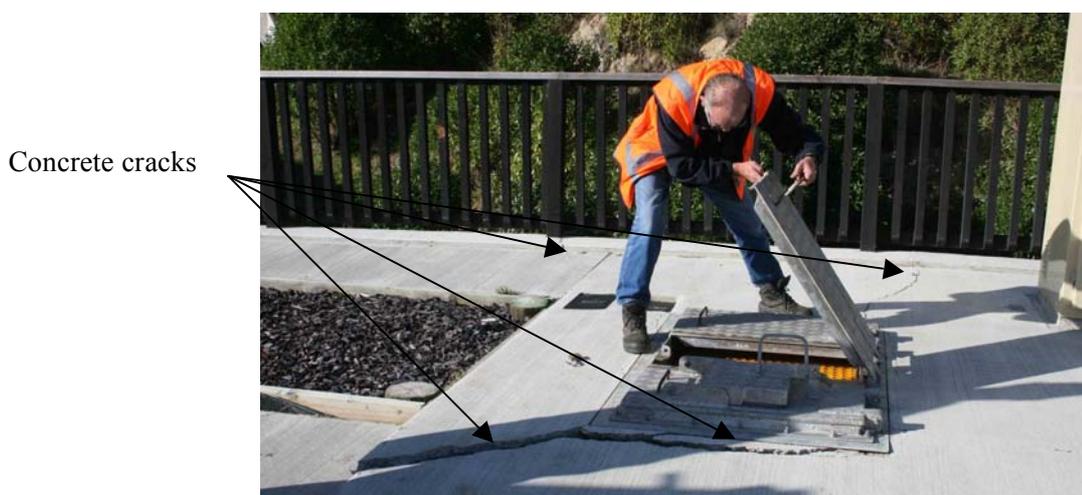
The earthquakes further consolidated the fill, resulting in significant cracks to the concrete and asphalt surrounds (Photograph 15). There was no damage to the pump station or discharge pipework.

Photograph 15: Black Rock Pump Station, Lyttleton (PS625): Earthquakes cracked concrete surrounds.

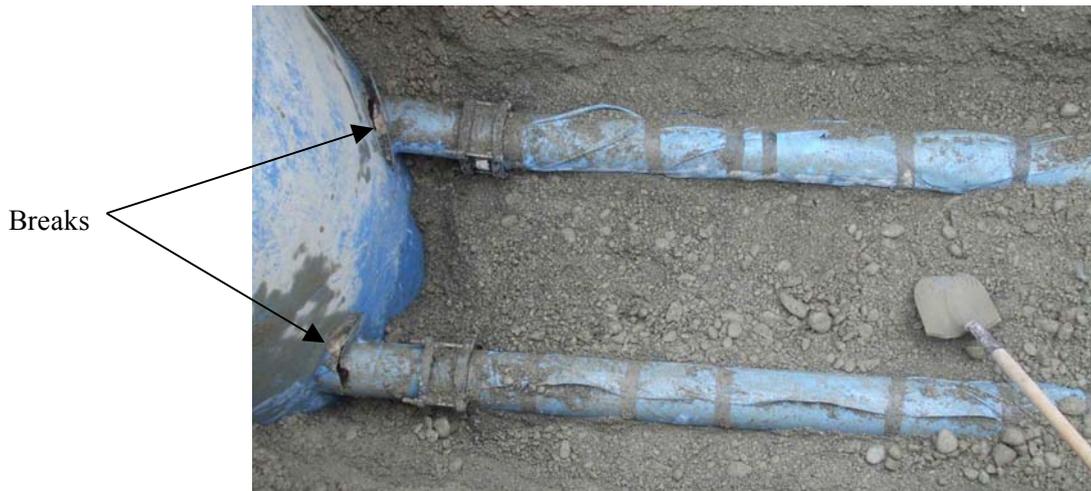
The Wigram pump station was installed in 2011 in a new subdivision. The pump station and valve chamber are 4 metres apart, and 150mm diameter ductile iron discharge pipes connect the two. The pump station was commissioned immediately prior to the series of earthquakes in June 2011. The earthquakes fractured the discharge piping just outside the pump station in the fibreglass spools (Photograph 16). The liquid tight envelope of the fibreglass vessel itself was not broken. Again, there was both vertical and horizontal displacement of the pipes; the maximum vertical displacement measured was 80mm downwards.

Photograph 16: Wigram Pump Station, Christchurch (PS101): Both 150mm diameter discharge pipes to the valve chamber fractured in the fibreglass pipe spool at the pump station wall.

It appeared that the ductile iron pipes (and not the pump station) were forced downwards by the earthquake, and as a result the fibreglass pipes fractured. The pump station and valve chamber were subsequently surveyed, but no significant movement vertically of either was found. It appears the earthquakes compacted the backfill around the pump station, forcing the discharge pipes downward, with the observed result.

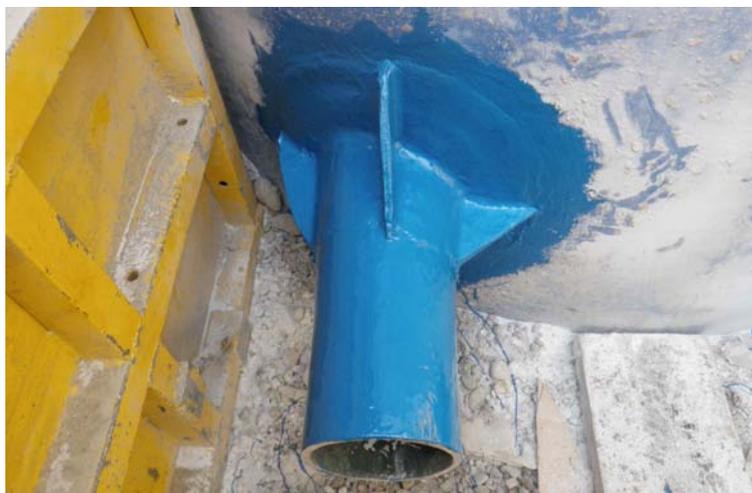
Photograph 17: Wigram Pump Station, Christchurch (PS101): Strengthened and gusseted fibreglass outlet pipe.

The fibreglass spools were strengthened and gusseted (Photograph 17), so that the weakest point is further out from the pump station wall and more accessible if damaged in the future. HDPE discharge piping was installed, and is now the standard for this work in Christchurch. It is not possible to totally stop earthquakes causing damage, but the measures taken will minimize any future damage and make subsequent repairs easier.
