LESSONS LEARNED REHABILITATING MANHOLES & PUMP STATIONS WITH FIBREGLASS LINERS

Ken Holyoake, Managing Director, ARMATEC Environmental Ltd

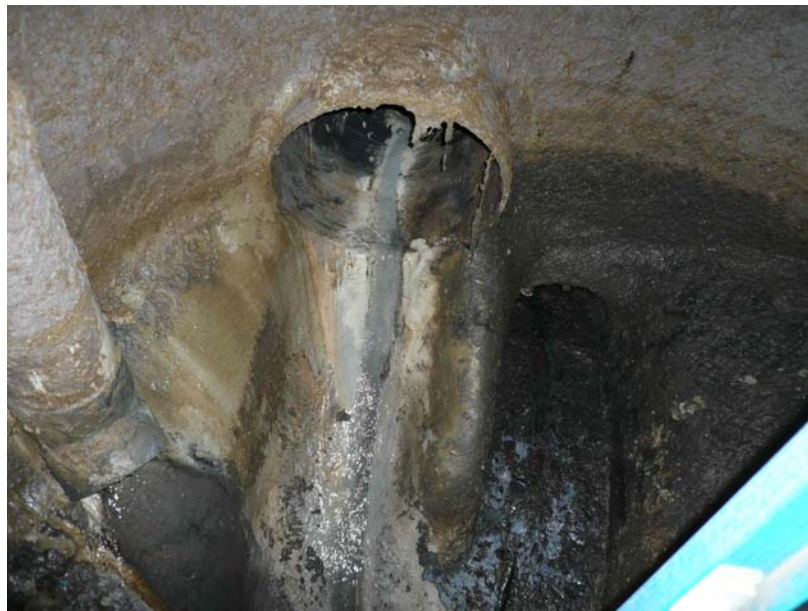
Photograph 4: Base of deep manhole in municipal sewer system coated with moisture tolerant and chemically resistant ARMALINE 1730 epoxy coating. Again, complex shapes require rehabilitation by coating.

Specialist coatings are used due to the complex shapes of manhole bases, with inlet and outlet pipes and haunching done to shape the flows. Successful coatings used are moisture tolerant epoxy coatings, formulated to give ultra low permeation and excellent chemical resistance. One coating that has a successful track record in this application is ARMALINE 1730 from ARMATEC. This moisture tolerant epoxy coating can adhere to a damp substrate and cure underwater. It is applied by hand application to a thickness of 1 to 3mm.

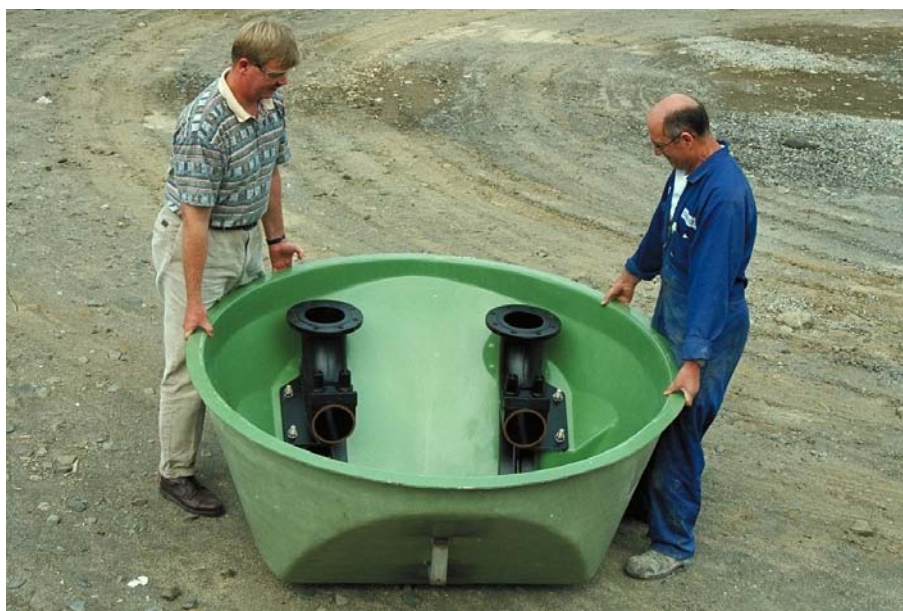
Photograph 5: FLYGT TOPS fiberglass base, with pump seating elbows installed, ready to install

The base of a pump station can be rehabilitated with coatings as described above, or a specialist fiberglass ‘TOPS’ base can be fitted when FLYGT pumps are used. This base can also be installed in new installations. The fiberglass base is factory fitted with the pump seating elbows bolted to the base and has a flange around the top for stability (Photograph 5).

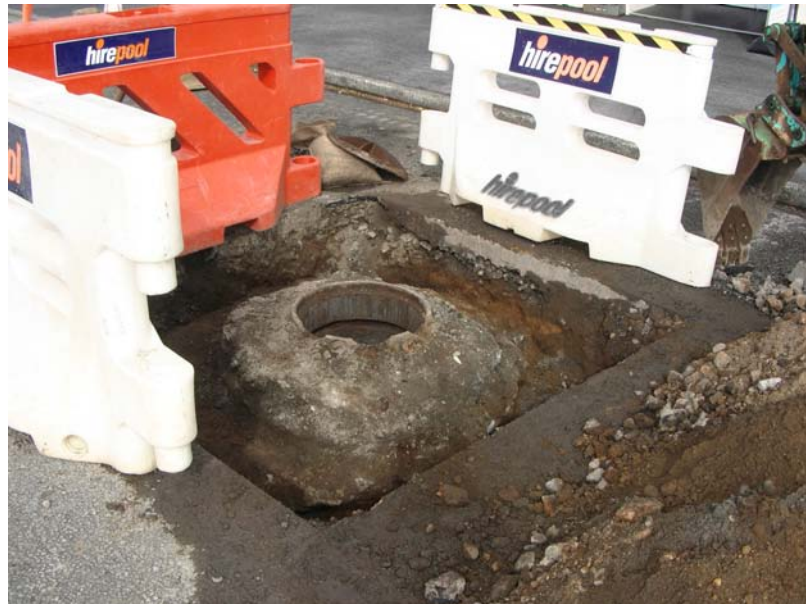
Photograph 8: Minimal excavation to remove manhole top in preparation for installing fiberglass liner.

The top of the manhole or pump station must be removed to allow the fiberglass liner to be installed. This excavation is relatively small (Photograph 8) compared to removing and replacing the entire unit. In some instances, where the surrounding soil is unstable, very large excavations may be required.

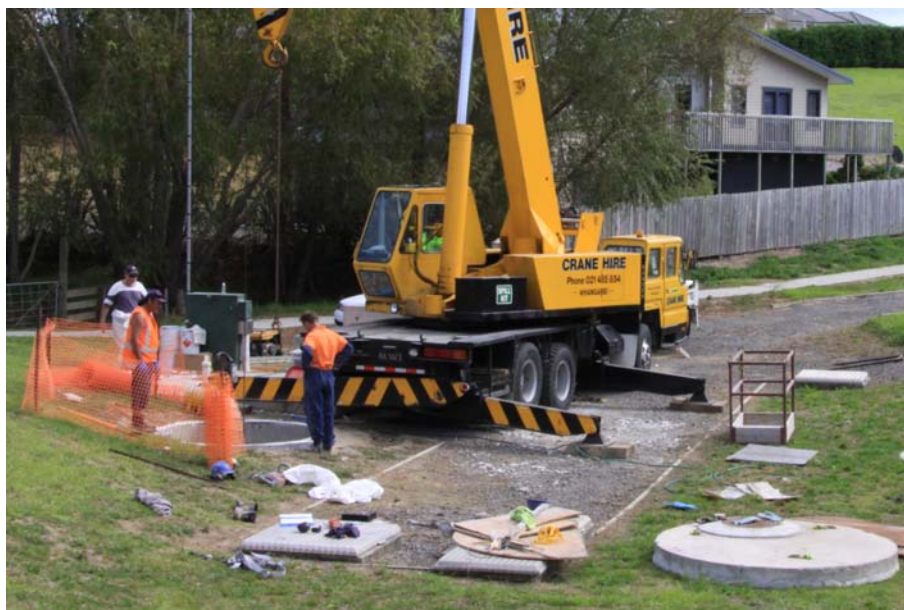
Photograph 9: Top off manhole, and preparing to install fiberglass liner.
