Green Dome Odour Filter

Installed on Air Release Valve

June 2011

On sewer at Long Mile Road, Rotorua; access road to the Redwood Forest.

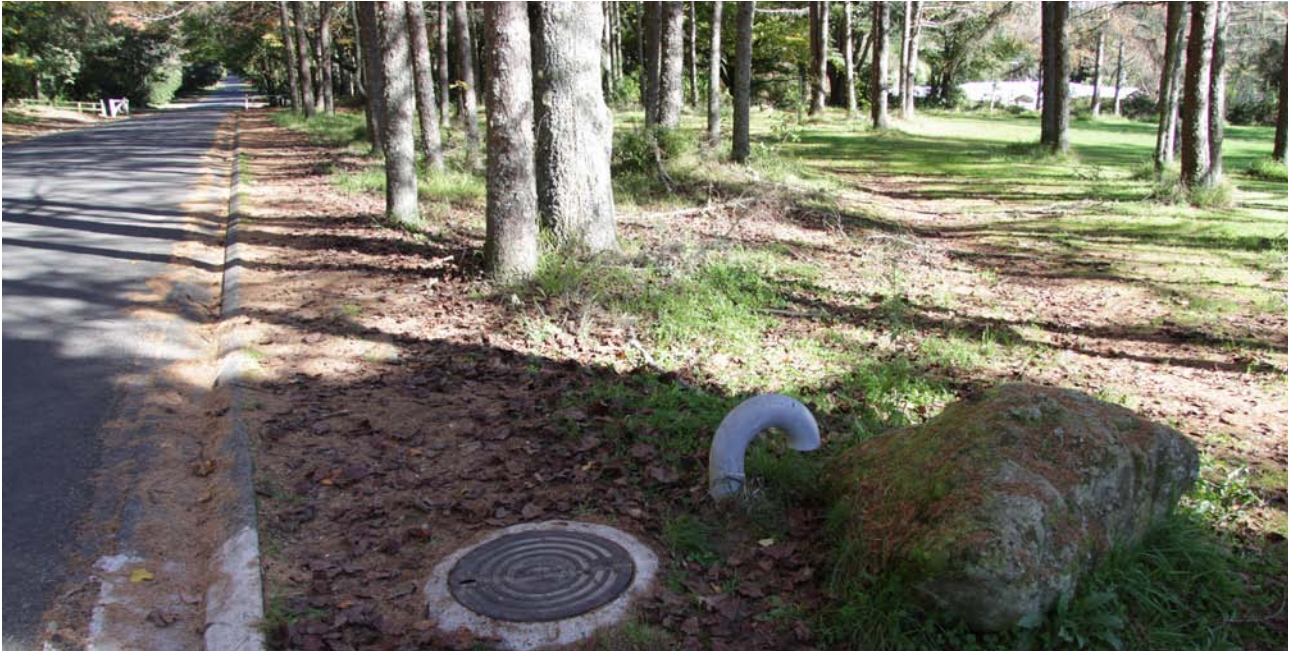
Before: Roadside air release valve vent. People often reported to the Visitors' Centre that there must be a dead animal beside the road. "Some days the smell was terrible", according to Dennis who walks the road every day with his dog.

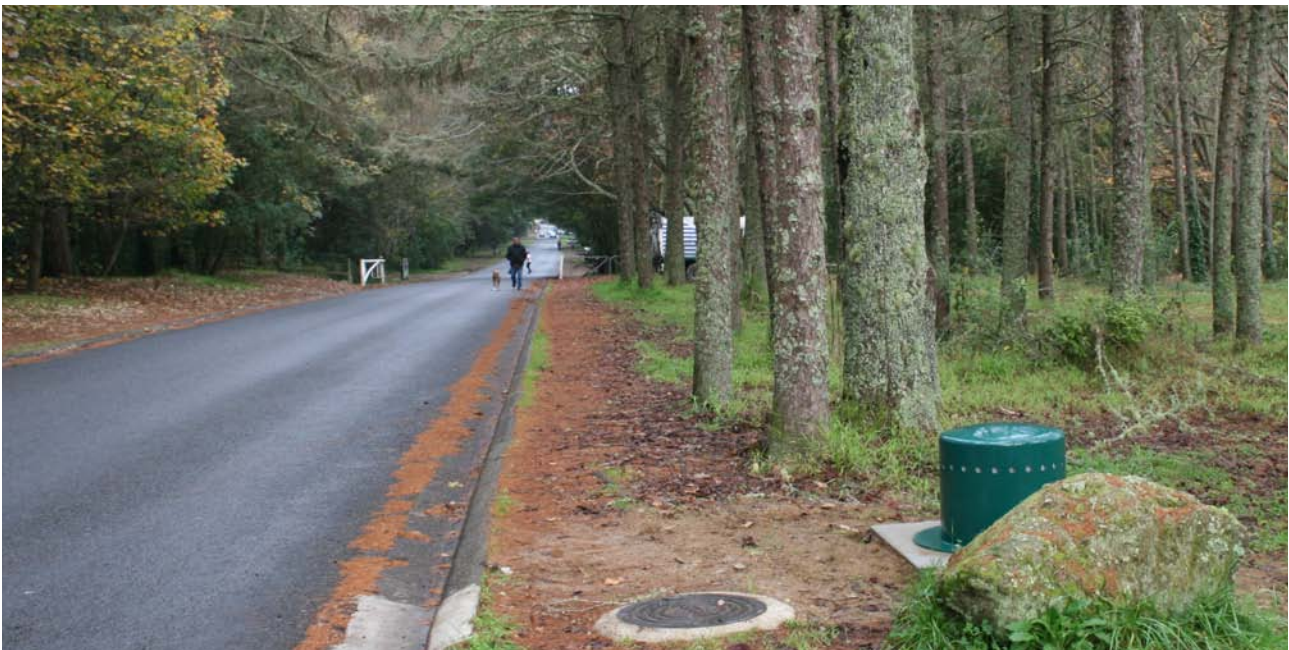
After: Green Dome Odour Filter: Hydrogen sulphide 'rotten egg' odour stopped as soon as it was installed. Made from robust corrosion-resistant fibreglass. Connecting duct and carbon bed are underground.

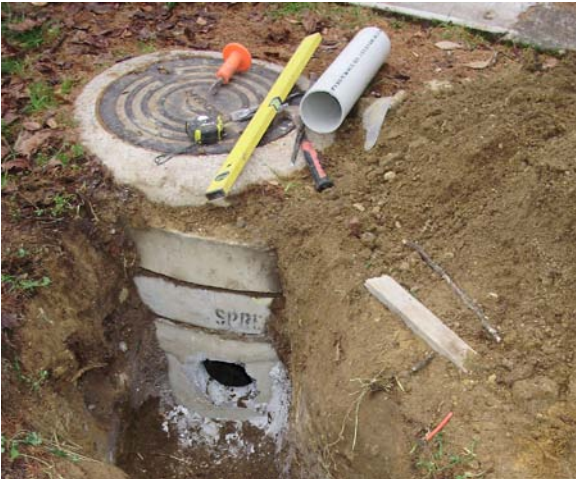
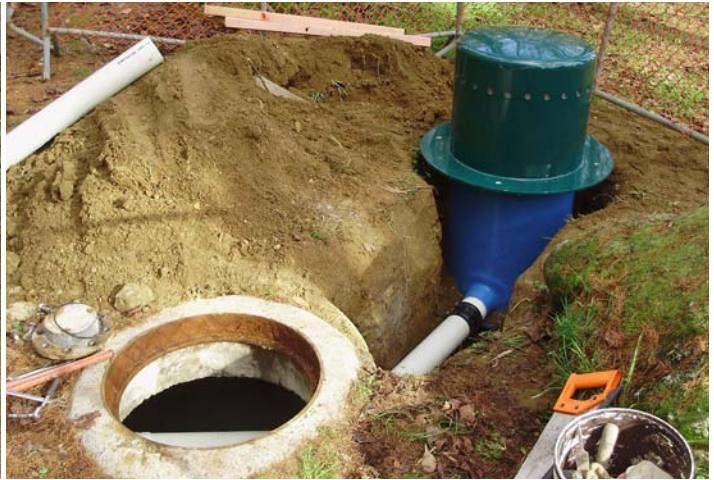
Left: Same hole through concrete manhole used for duct to Green Dome. Right: Duct sloped towards Green Dome to drain condensation away through holes in base module. Heights set to suit local ground levels.

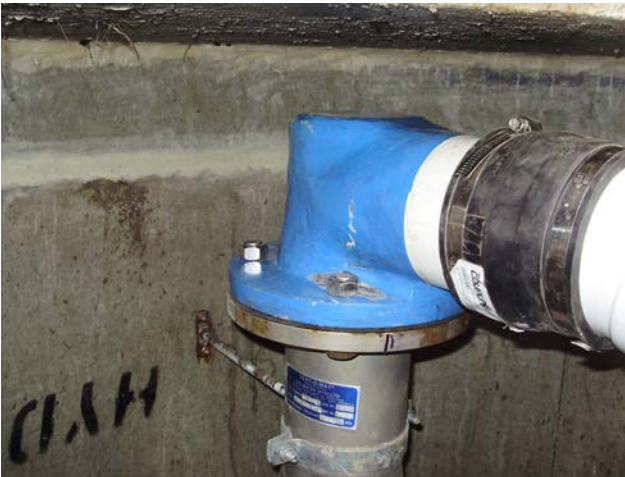
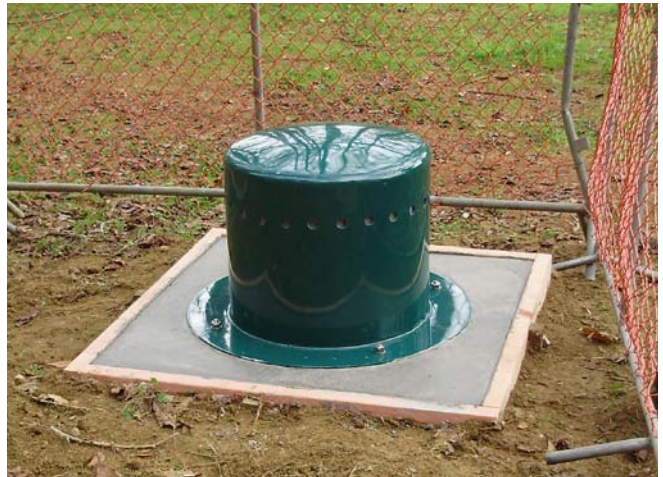
Left: Flanged fibreglass low profile fitting to match air release valve. Flexible joint allows for thermal expansion and contraction. Right: Green Dome base in concrete pad to secure in position.

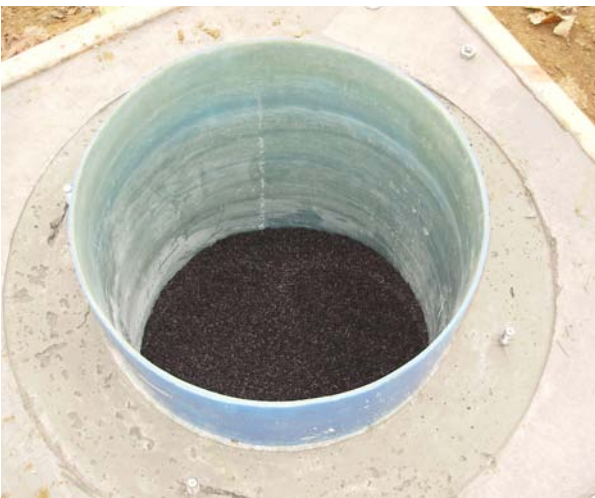
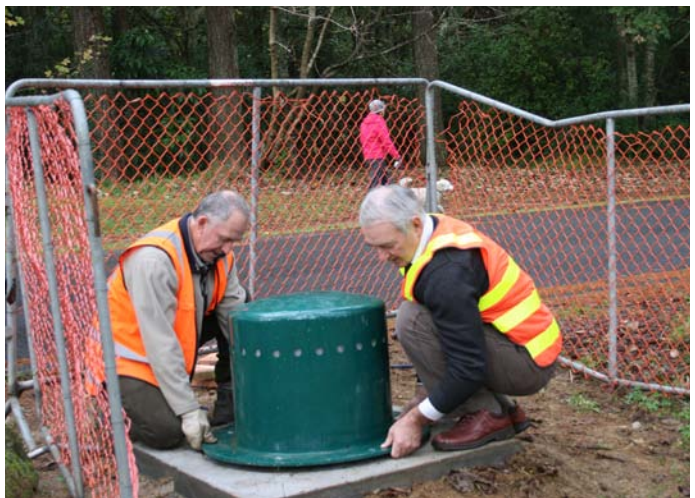
Left: Carbon loaded into base module, with room for more carbon if needed. Top of base module above ground, so carbon cannot be flooded by ground water. Right: Top module bolted back in place.
